**DOUGLAS AIRCRAFT COMPANY  
LONG BEACH, CALIFORNIA**

**RCRA COMPLIANCE EVALUATION INSPECTION**

**RCRA INSPECTION REPORT**  
**U.S. ENVIRONMENTAL PROTECTION AGENCY, REGION 9**  
**HAZARDOUS WASTE MANAGEMENT DIVISION**  
**WASTE COMPLIANCE BRANCH**

Date of Inspection : August 21, 1990

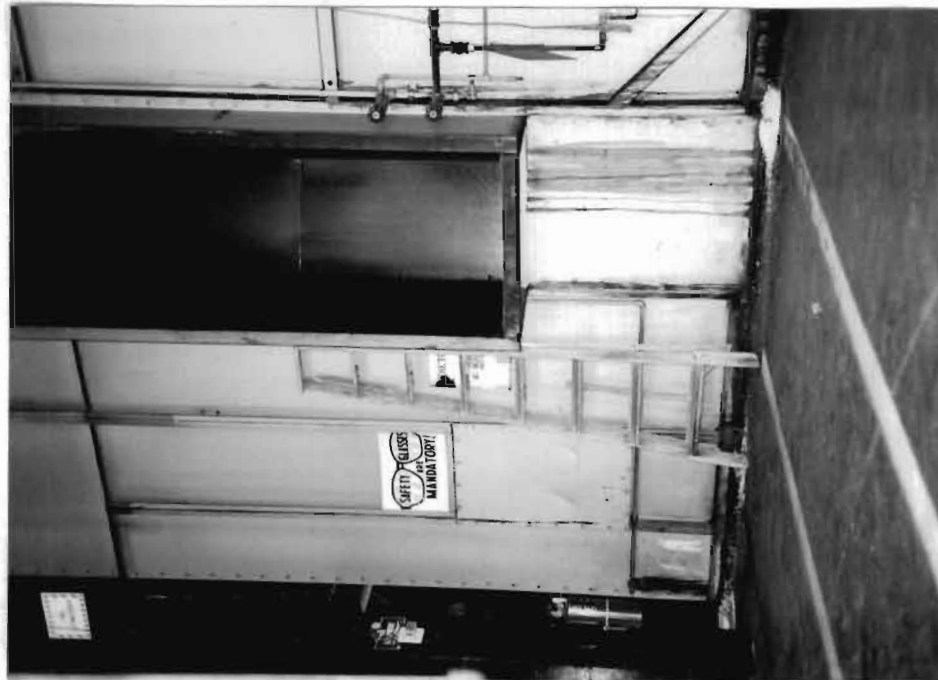
Photograph No. 1

Inspectors noted leaking around the spray booth and the use of absorbent in some areas to contain this leakage (Appendix C, Photograph 1). Inspectors requested and received a Material Safety Data Sheet (MSDS) for the fluorescent penetrant (Appendix D). Facility representatives stated that, based on the MSDS and by knowledge of process, the used penetrant is not a RCRA-regulated hazardous waste.

Subject: Fluorescent Penetrant Spray Booth

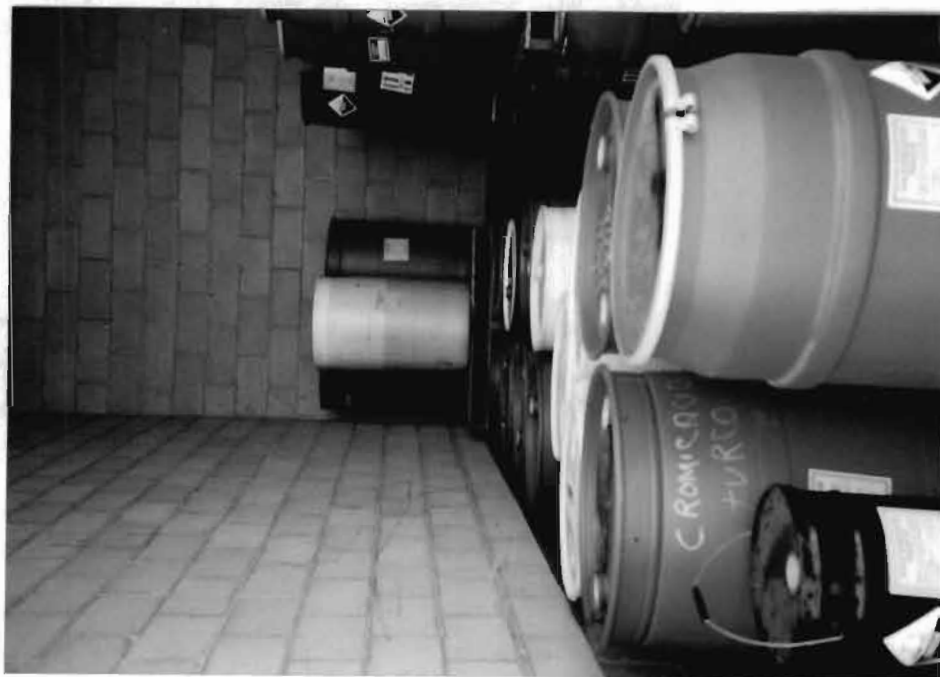
Photograph No. 2

Approximately 40, 55-gallon drums of acidic wastes were in the second bay during the inspection. These drums were primarily poly drums, stored on pallets, and stacked two-high in some areas. This bay appeared to be near full-capacity. The drums were all labeled and consisted primarily of corrosive liquid and solid wastes (salts) classified as D002 and D007 wastes. All drums inspected were in good condition, and inspectors did not note any leakage on the floor of the bay. However, there was inadequate aisle space and inspectors could not access drums along the sides of the bay (Appendix C, Photographs 2 and 3).

Subject: Acidic Wastes Bay in the Accumulation Area (Note Inadequate Aisle Space)

- One unlabeled drum of desmut in the accumulation area did not have an accumulation date marked on it. [40 CFR Part 262.34(a)(2)]
- There was inadequate aisle space in the bay containing acidic wastes in the accumulation area at Building 47 (Appendix C, Photographs 2 and 3). [40 CFR Part 262.34(a)(4) directing to 40 CFR Part 265.35]

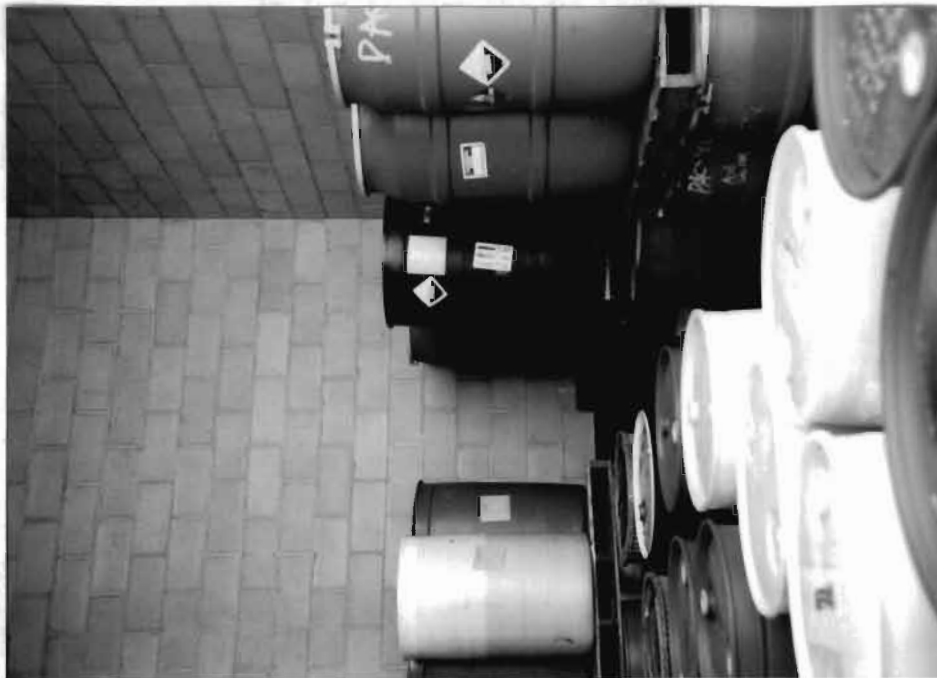
Photograph No. 3

Subject: Acidic Wastes Bay in the Accumulation Area (Note Inadequate Aisle Space)

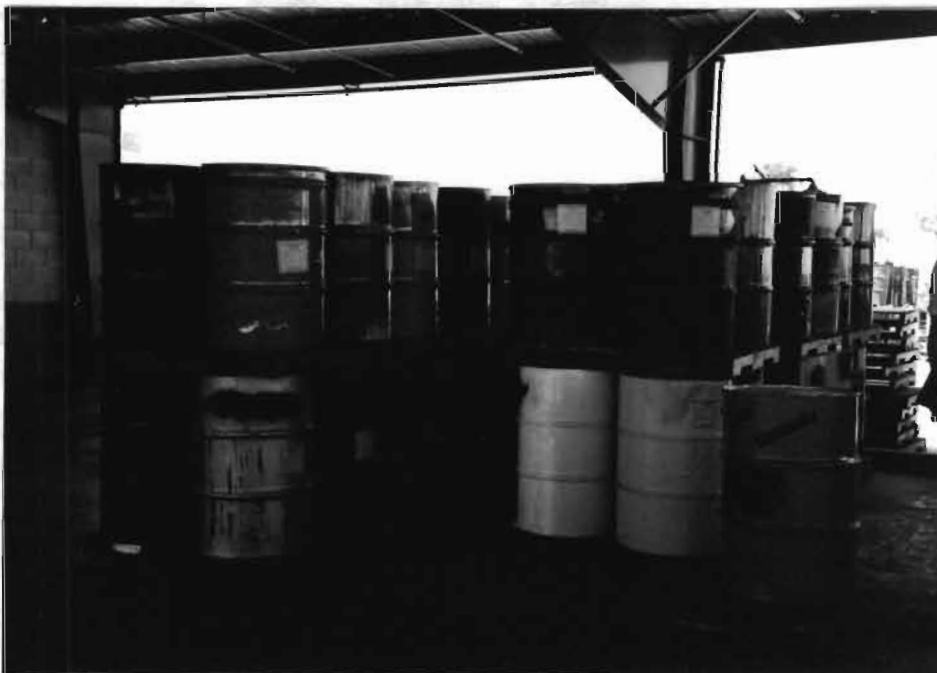
Photograph No. 4

During the inspection, there were over 100, 55-gallon drums of flammable wastes in the third bay, which is several times larger than the other bays (Appendix C, Photograph 4). According to facility representatives, the drummed wastes in this bay (primarily solvent/paint sludges) are consistently produced at the facility and have similar characteristics. However, inspectors noted that these drums were classified inconsistently: some drums were classified as D001/F002/F003/F005 and some were classified as F002/F003/F005. Facility representatives, stated that the D001/F002/F003/F005 classification is most accurate and would be used to consistently classify these wastes in the future.

Subject: Flammable Wastes Bay in the Accumulation Area

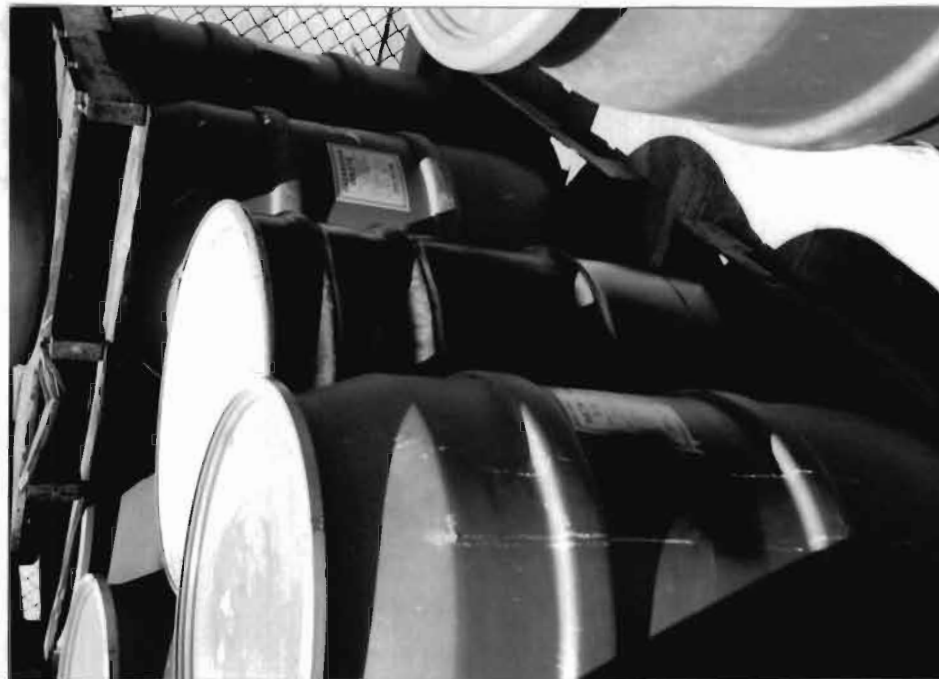
Photograph No. 5

One of the drums of D001/D002 desmut filter cake was unlabelled (see black drum in Appendix C, Photographs 5 and 6). As such, no accumulation date was noted on the drum. However, this drum was marked in paint as "hazardous waste" and "desmut."

Subject: Unlabeled Drum of Desmut Waste in the Accumulation Area

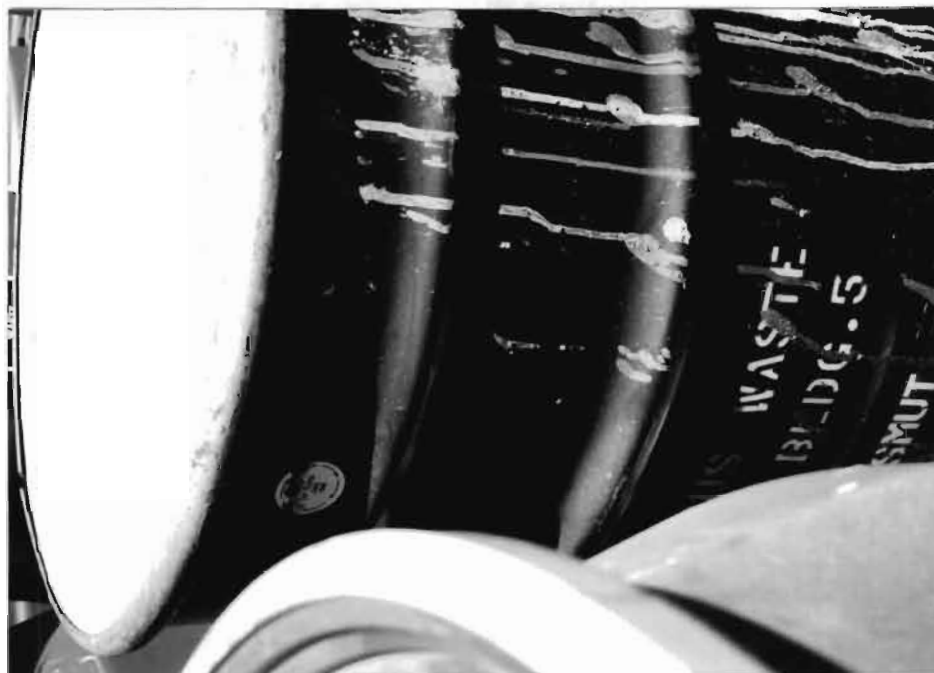
Photograph No. 6

Subject: Unlabeled Drum of Desmut Waste in the Accumulation Area

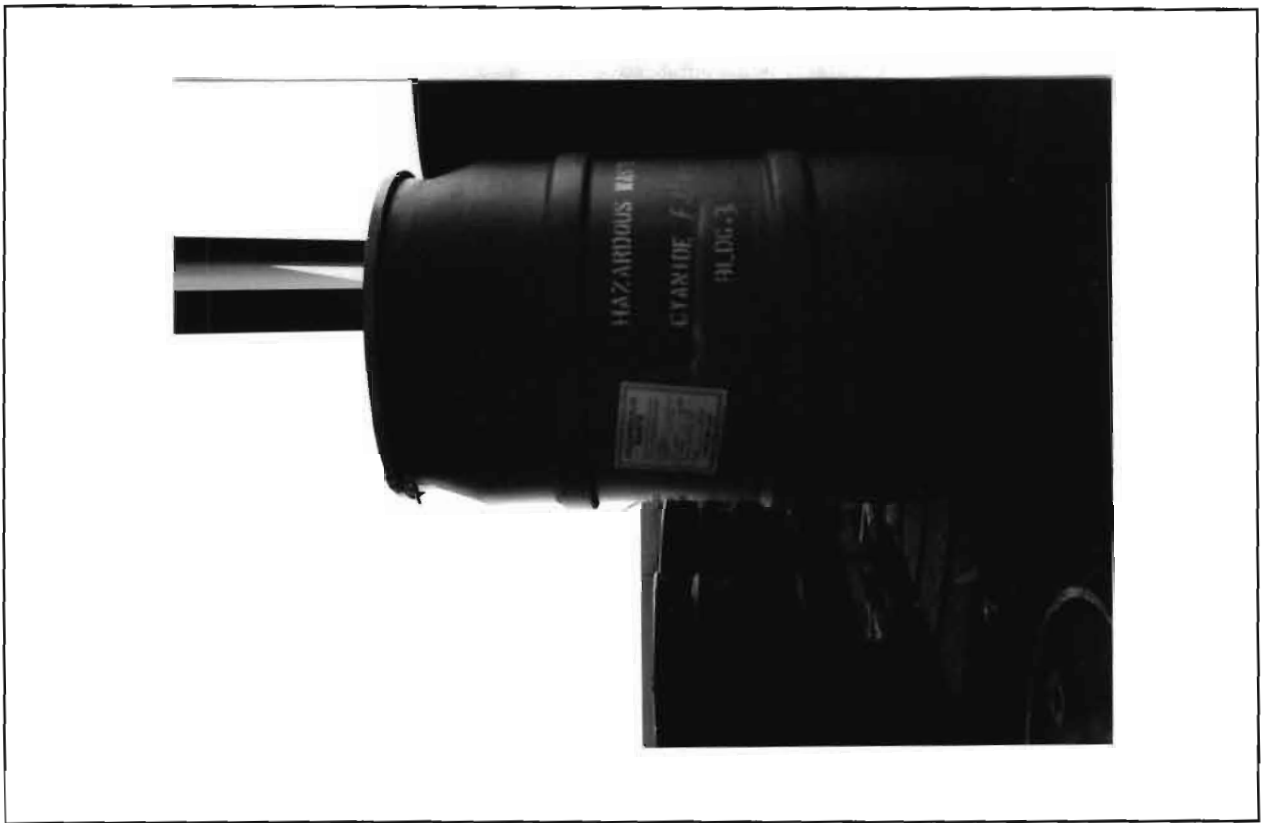
Photograph No. 7

In addition, inspectors noted one 55-gallon drum that was marked in paint as "hazardous waste - cyanide filters" (Appendix C, Photograph 7). However, the label on the drum indicated the waste was "non-RCRA." Facility representatives stated that the waste was RCRA-regulated and that the label would be corrected.
